**Flood Control Project Maintenance
Levee Inspections**
LMA District Cover Sheet
Spring 2017 Levee Inspection Results

Reclamation District No. 0537 Lovdal

Spring 2017 Levee Inspection Results

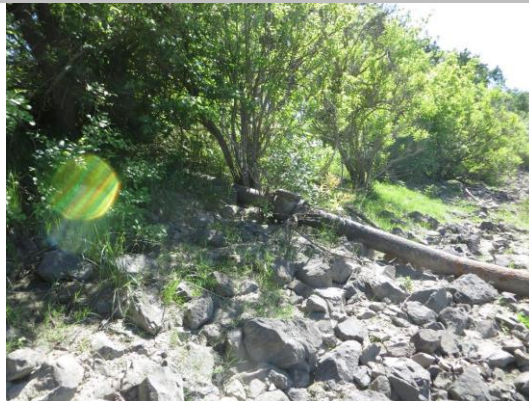
Photo 1 of 3 : UCIP_SP_2017_46803_74402.jpg

LM Start	0.07	Rating **	M	Issue No.	477 (cont)
LM End	0.07	Issue Type +	En	Location *	WS

Pipe visible along WS slope.

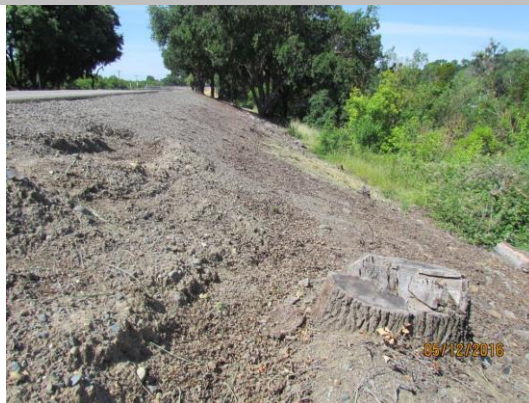
Photo 1 of 1 : SP_2017_RD0537_173_32_20170320_00028.jpg

LM Start	0.42	Rating **	N	Issue No.	32
LM End	0.42	Issue Type +	Ma	Location *	WS
Category	Earthen Levee			GPS Latitude/Longitude	
				Start	End
Item	Trim / Thin Trees			38.646811 °	38.646811 °
				-121.578241 °	-121.578241 °
DWR ID	DWR_RD0537_01_s_2016_32				
Comment Code					
T5 : Tree stumps.					
Inspector Comment

View of the tree stump on the waterward side of the levee looking downstream. Spring 2016.

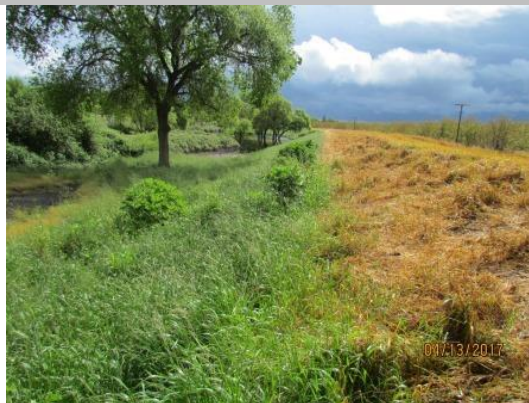
Photo 1 of 1 : SP_2017_RD0537_173_67_20170413_00096.jpg

LM Start	0.56	Rating **	U	Issue No.	67
LM End	0.77	Issue Type +	Ma	Location *	WS
Category	Earthen Levee			GPS Latitude/Longitude	
				Start	End
Item	Vegetation			38.647605 °	38.647330 °
				-121.575932 °	-121.572265 °
DWR ID	DWR_RD0537_01_s_2017_67				
Comment Code					
V1 : Control annual grass and weeds on the levee slopes and easements.					
Inspector Comment

Tall grass on waterside levee slope, blocking visibility. Spring 2017.

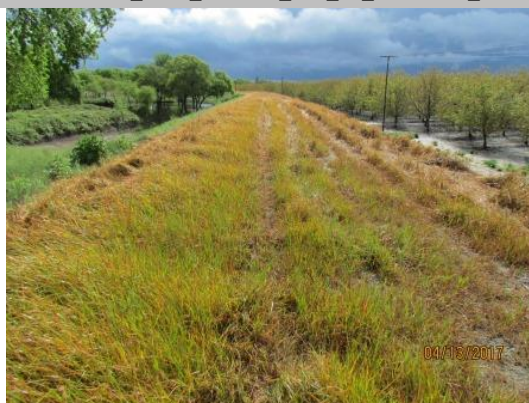
Photo 1 of 1 : SP_2017_RD0537_173_66_20170413_00097.jpg

LM Start	0.56	Rating **	M	Issue No.	66
LM End	0.77	Issue Type +	Ma	Location *	CR
Category	Earthen Levee			GPS Latitude/Longitude	
				Start	End
Item	Vegetation			38.647603 °	38.647340 °
				-121.575925 °	-121.572287 °
DWR ID	DWR_RD0537_01_s_2017_66				
Comment Code					
V1 : Control annual grass and weeds on the levee slopes and easements.					
Inspector Comment

Tall grass on levee crown, blocking visibility. Spring 2017.

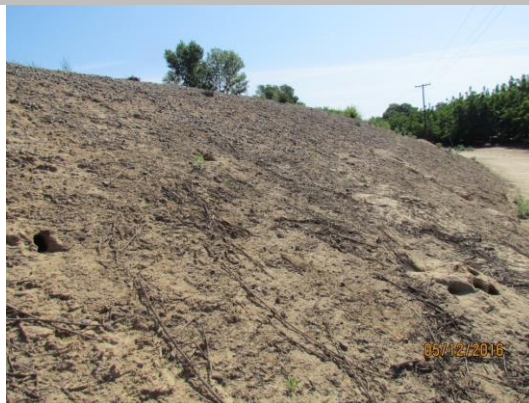
Photo 1 of 1 : SP_2017_RD0537_173_27_20170320_00023.jpg

LM Start	0.68	Rating **	M	Issue No.	27
LM End	0.68	Issue Type +	Ma	Location *	LS
Category	Earthen Levee			GPS Latitude/Longitude	
				Start	End
Item	Animal Control			38.647065 °	38.647065 °
				-121.573753 °	-121.573753 °
DWR ID	DWR_RD0537_01_s_2017_27				
Comment Code					
A3 : No rodents visible, but rodent burrows visible; need to backfill and compact or grout burrows.					
Inspector Comment

View of the rodent holes on the landward side of the levee looking downstream. Spring 2016.

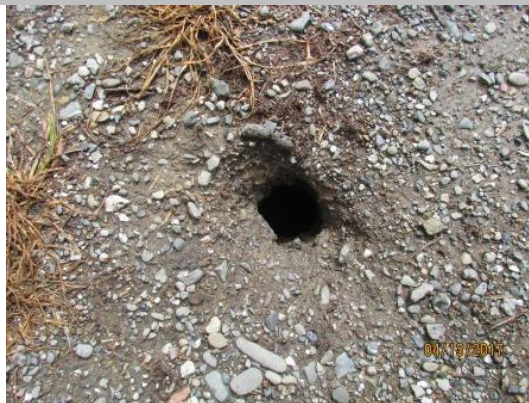
Photo 1 of 1 : SP_2017_RD0537_173_68_20170413_00098.jpg

LM Start	0.69	Rating **	M	Issue No.	68
LM End	0.69	Issue Type +	Ma	Location *	CR
Category	Earthen Levee			GPS Latitude/Longitude	
				Start	End
Item	Animal Control			38.647032 °	38.647032 °
				-121.573617 °	-121.573617 °
DWR ID	DWR_RD0537_01_s_2017_68				
Comment Code					
A3 : No rodents visible, but rodent burrows visible; need to backfill and compact or grout burrows.					
Inspector Comment

Deep rodent hole on levee crown. Spring 2017.

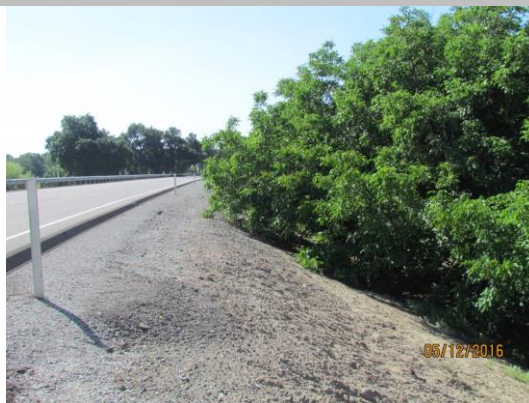
Photo 1 of 1 : SP_2017_RD0537_173_28_20170320_00024.jpg

LM Start	1.05	Rating **	M	Issue No.	28
LM End	1.08	Issue Type +	Ma	Location *	LS
Category	Earthen Levee			GPS Latitude/Longitude	
				Start	End
Item	Trim / Thin Trees			38.644973 °	38.644686 °
				-121.568153 °	-121.567903 °
DWR ID	DWR_RD0537_01_s_2016_28				
Comment Code					
T1 : Trim trees to at least five feet above ground level.					
Inspector Comment

View of the trees on the landward side of the levee looking downstream. Spring 2016.

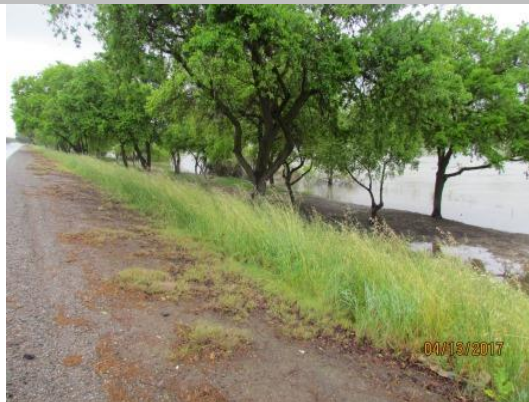
Photo 1 of 1 : SP_2017_RD0537_173_58_20170413_00092.jpg

LM Start	1.09	Rating **	U	Issue No.	58
LM End	3.42	Issue Type +	Ma	Location *	WS
Category	Earthen Levee			GPS Latitude/Longitude	
				Start	End
Item	Vegetation			38.644610 °	38.611362 °
				-121.567780 °	-121.561960 °
DWR ID	DWR_RD0537_01_s_2017_58				
Comment Code					
V1 : Control annual grass and weeds on the levee slopes and easements.					
Inspector Comment

Tall grass on waterside levee slope, blocking visibility. Spring 2017.

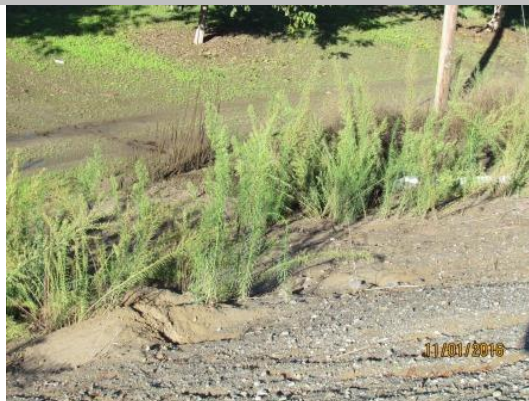
Photo 1 of 2 : SP_2017_RD0537_173_36_20170320_00033.jpg

LM Start	1.19	Rating **	U	Issue No.	36
LM End	1.19	Issue Type +	Ma	Location *	LS
Category	Earthen Levee			GPS Latitude/Longitude	
				Start	End
Item	Animal Control			38.643355 °	38.643355 °
				-121.566895 °	-121.566895 °
DWR ID	DWR_RD0537_01_f_2016_36				
Comment Code					
A3 : No rodents visible, but rodent burrows visible; need to backfill and compact or grout burrows.					
Inspector Comment

Rodent burrow with large amount of soil out. Fall 2016.

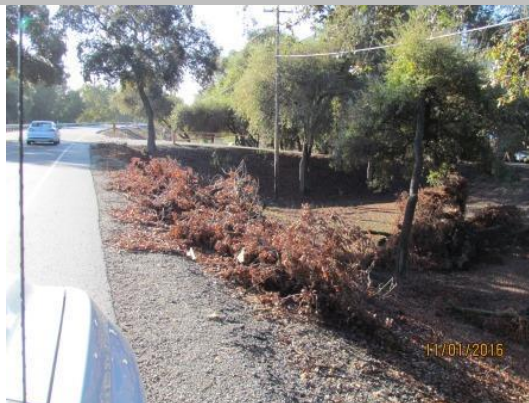
Photo 1 of 1 : SP_2017_RD0537_173_38_20170320_00036.jpg

LM Start	1.28	Rating **	M	Issue No.	38
LM End	1.28	Issue Type +	En	Location *	LS
Category	Earthen Levee			GPS Latitude/Longitude	
				Start	End
Item	Encroachments			38.642089 °	38.642089 °
				-121.566260 °	-121.566260 °
DWR ID	DWR_RD0537_01_f_2016_38				
Comment Code					
PR : Prunings					
Inspector Comment

View of debris on landside slope. Fall 2016.

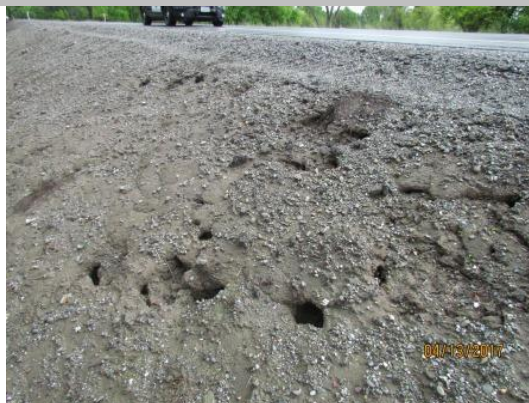
Photo 1 of 1 : SP_2017_RD0537_173_59_20170413_00094.jpg

LM Start	1.81	Rating **	M	Issue No.	59
LM End	1.81	Issue Type +	Ma	Location *	LS
Category	Earthen Levee			GPS Latitude/Longitude	
				Start	End
Item	Animal Control			38.634585 °	38.634585 °
				-121.564604 °	-121.564604 °
DWR ID	DWR_RD0537_01_s_2017_59				
Comment Code					
A3 : No rodents visible, but rodent burrows visible; need to backfill and compact or grout burrows.					
Inspector Comment

View of rodent holes on landside levee slope. Spring 2017.

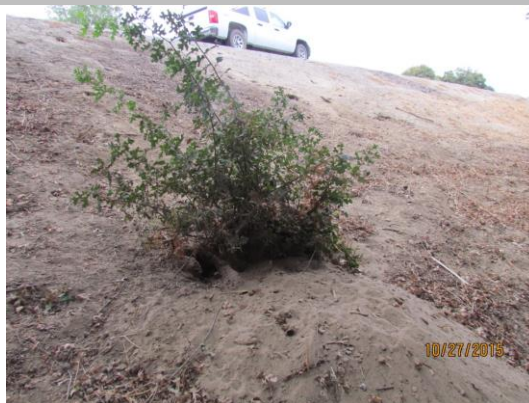
Photo 1 of 3 : SP_2017_RD0537_173_40_20170320_00038.jpg

LM Start	1.91	Rating **	U	Issue No.	40
LM End	1.91	Issue Type +	Ma	Location *	LS
Category	Earthen Levee			GPS Latitude/Longitude	
				Start	End
Item	Animal Control			38.633148 °	38.633148 °
				-121.564520 °	-121.564520 °
DWR ID	DWR_RD0537_01_s_2012_40				
Comment Code					
A3 : No rodents visible, but rodent burrows visible; need to backfill and compact or grout burrows.					
Inspector Comment

View of the rodent holes on the landward side of the levee looking down. Fall 2015.

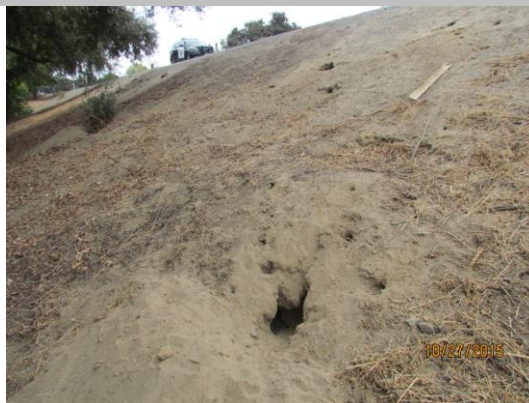
Photo 3 of 3 : SP_2017_RD0537_173_40_20170320_00040.jpg

LM Start	1.91	Rating **	U	Issue No.	40 (cont)
LM End	1.91	Issue Type +	Ma	Location *	LS

View of the rodent holes on the landward side of the levee looking upstream. There are more than 2 cubic feet of material from the hole Fall 2015.

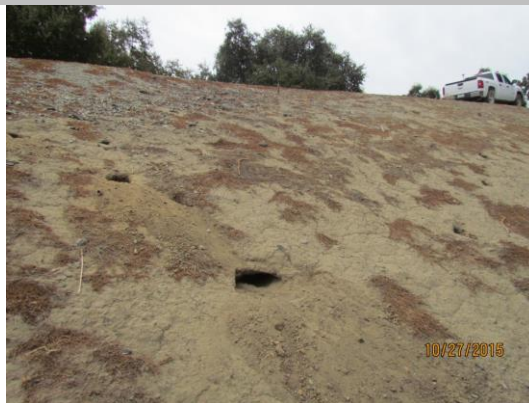
Photo 1 of 1 : SP_2017_RD0537_173_7_20170320_00005.jpg

LM Start	2.50	Rating **	M	Issue No.	7
LM End	2.50	Issue Type +	Ma	Location *	LS
Category	Earthen Levee			GPS Latitude/Longitude	
				Start	End
Item	Animal Control			38.624549 °	38.624549 °
				-121.563650 °	-121.563650 °
DWR ID	DWR_RD0537_01_s_2013_7				
Comment Code					
A3 : No rodents visible, but rodent burrows visible; need to backfill and compact or grout burrows.					
Inspector Comment

View of the rodent hole on the landward side of the levee. Fall 2015.

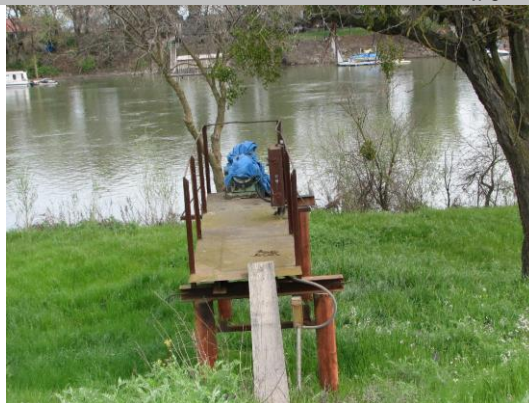
Photo 2 of 3 : UCIP_SP_2017_46035_17007.jpg

LM Start	2.72	Rating **	M	Issue No.	478 (cont)
LM End	2.72	Issue Type +	En	Location *	LS
Category	Supplemental			GPS Latitude/Longitude	
				Start	End
Item	DWR UCIP Field Study			38.621437 °	38.621437 °
				-121.563373 °	-121.563373 °
DWR ID					
Comment Code					
Inspector Comment					
FS_ID:46035 DS_ID:178 EP_NO: N/A Repair Type: Non-Urgent Crossing Status: Found UCIP Comments: Wasted pipe and valve not visible due to vegetation. FIELD_STRUCT_DESC: 12-inch pipe through the levee, 4.5 feet below the crown. Slant pump column on the waterward bank. Timber walkway (not found) mounted on pile structure across the berm. Siphon breaker in CM pipe riser on the landward slope. Concrete standpipe on the landward side. 6-inch wasted pipe down bank, gate valve on waste line. A 2" electrical conduit through the levee. FS Date: 3/18/2013

WS- closer view of pump, pipe and steel structure.

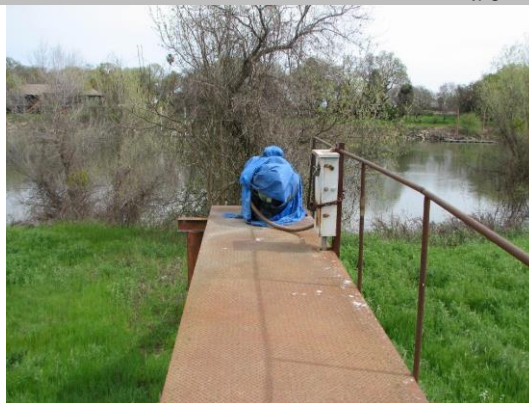
Photo 1 of 3 : UCIP_SP_2017_46037_17027.jpg

LM Start	2.84	Rating **	M	Issue No.	479
LM End	2.84	Issue Type +	En	Location *	LS
Category	Supplemental			GPS Latitude/Longitude	
				Start	End
Item	DWR UCIP Field Study			38.619674 °	38.619674 °
				-121.563330 °	-121.563330 °
DWR ID					
Comment Code					
Inspector Comment					
FS_ID:46037 DS_ID:179 EP_NO: N/A Repair Type: Non-Urgent Crossing Status: Found UCIP Comments: A 6-inch wasted pipe down bank, gate valve on waste line- not visible due to the vegetation. FIELD_STRUCT_DESC: 12-inch pipe through the levee, 7.0 feet below the crown. Slant pump column on the bank. Steel walkway mounted on pile structure across the berm to pump. Burried siphon breaker in CM pipe riser on the landward slope. Concrete standpipe not found on LS but a shallow CM standpipe found on cultivated field. FS Date: 3/18/2013

WS- overview of slanted pump on steel structure.

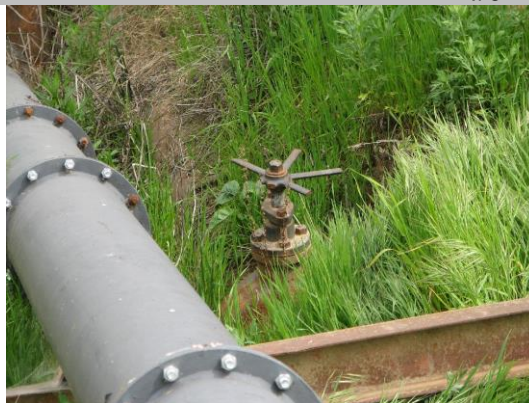
Photo 2 of 3 : UCIP_SP_2017_46806_17037.jpg

LM Start	2.93	Rating **	M	Issue No.	480 (cont)
LM End	2.93	Issue Type +	En	Location *	LS

WS- main pipe and waste pipe with gate valve

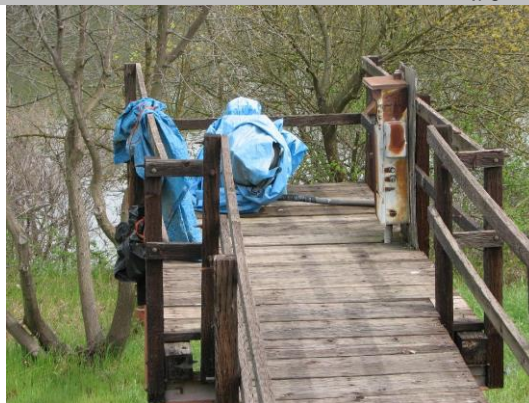
Photo 2 of 3 : UCIP_SP_2017_46041_17170.jpg

LM Start	3.06	Rating **	M	Issue No.	481 (cont)
LM End	3.06	Issue Type +	En	Location *	WS

WS- covered slanted pump on timber platform.

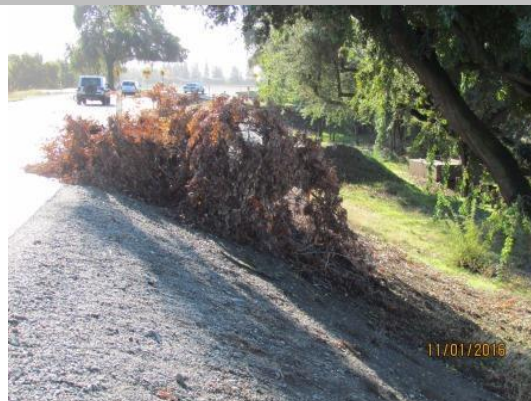
Photo 1 of 1 : SP_2017_RD0537_173_44_20170320_00044.jpg

LM Start	3.55	Rating **	A/W	Issue No.	44
LM End	3.55	Issue Type +	Ma	Location *	LS
Category	Earthen Levee			GPS Latitude/Longitude	
				Start	End
Item	Encroachments			38.609695 °	38.609695 °
				-121.560990 °	-121.560990 °
DWR ID	DWR_RD0537_01_f_2016_44				
Comment Code					
PR : Prunings					
Inspector Comment

Prunings on LS slope. Fall 2016.

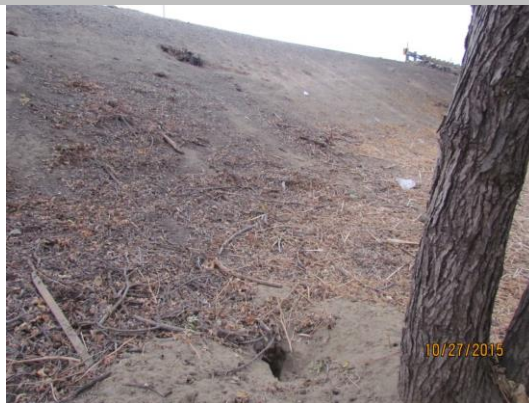
Photo 2 of 4 : SP_2017_RD0537_173_15_20170320_00011.jpg

LM Start	3.63	Rating **	M	Issue No.	15 (cont)
LM End	3.63	Issue Type +	Ma	Location *	LS

More rodent holes a little further upstream. Fall 2015.

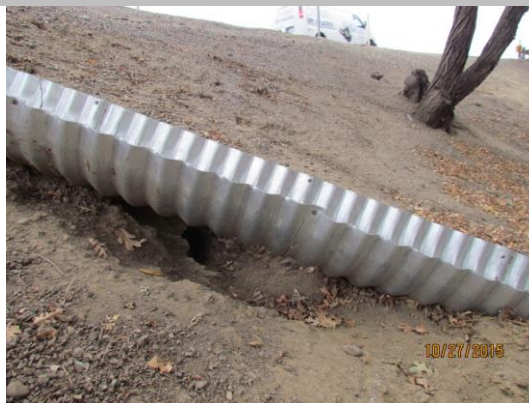
Photo 3 of 4 : SP_2017_RD0537_173_15_20170320_00012.jpg

There is a rodent hole under the pipe spill way. Fall 2015.

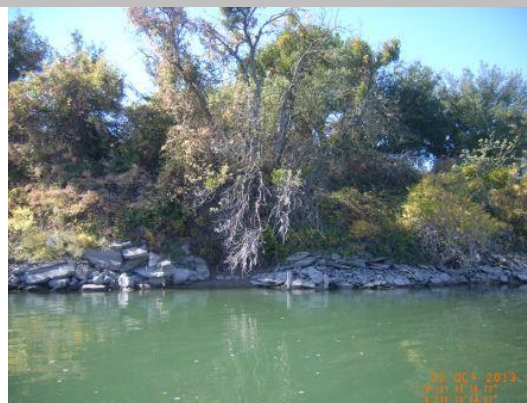
Photo 1 of 1 : SP_2017_RD0537_173_1_20170320_00001.jpg

LM Start	4.27	Rating **	M	Issue No.	1
LM End	4.32	Issue Type +	Ma	Location *	WS
Category	Supplemental			GPS Latitude/Longitude	
				Start	End
Item	2015 USACE Erosion Survey, DRAFT			38.601388 °	38.600907 °
				-121.553250 °	-121.552815 °
DWR ID	DWR_RD0537_01_s_2016_1				
Comment Code					
Inspector Comment					
1997 - This may have been a cobble rehabilitation site to the 1957 cobble that was place all the way to the I-80 Bridge. 2000 - Local damage induced by human use. 2003 - Site is still very close to the levee and into the levee toe. 2011 - One new tree has fallen. 2015: 62.9 and 63.0 have been combined into one site. [2015 Site ID: SAC 62-9 RI]

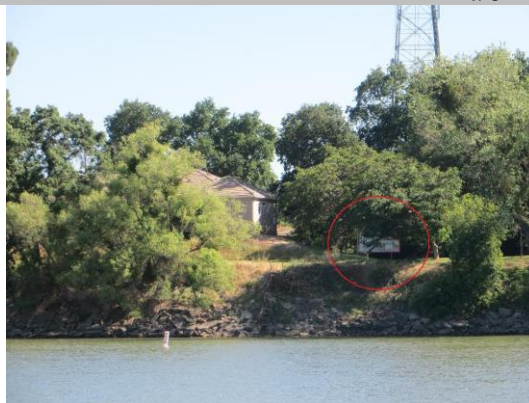
Photo 1 of 3 : UCIP_SP_2017_45024_74020.jpg

LM Start	4.35	Rating **	M	Issue No.	483 (cont)
LM End	4.35	Issue Type +	En	Location *	WS

Red circle shows location of sign on opposite bank.
